Electrical Conductivity of Plate Bottom Side in  
Longitudinal Transverse Direction Across Plate

T7651 Longitudinal Transverse UTS & TYS

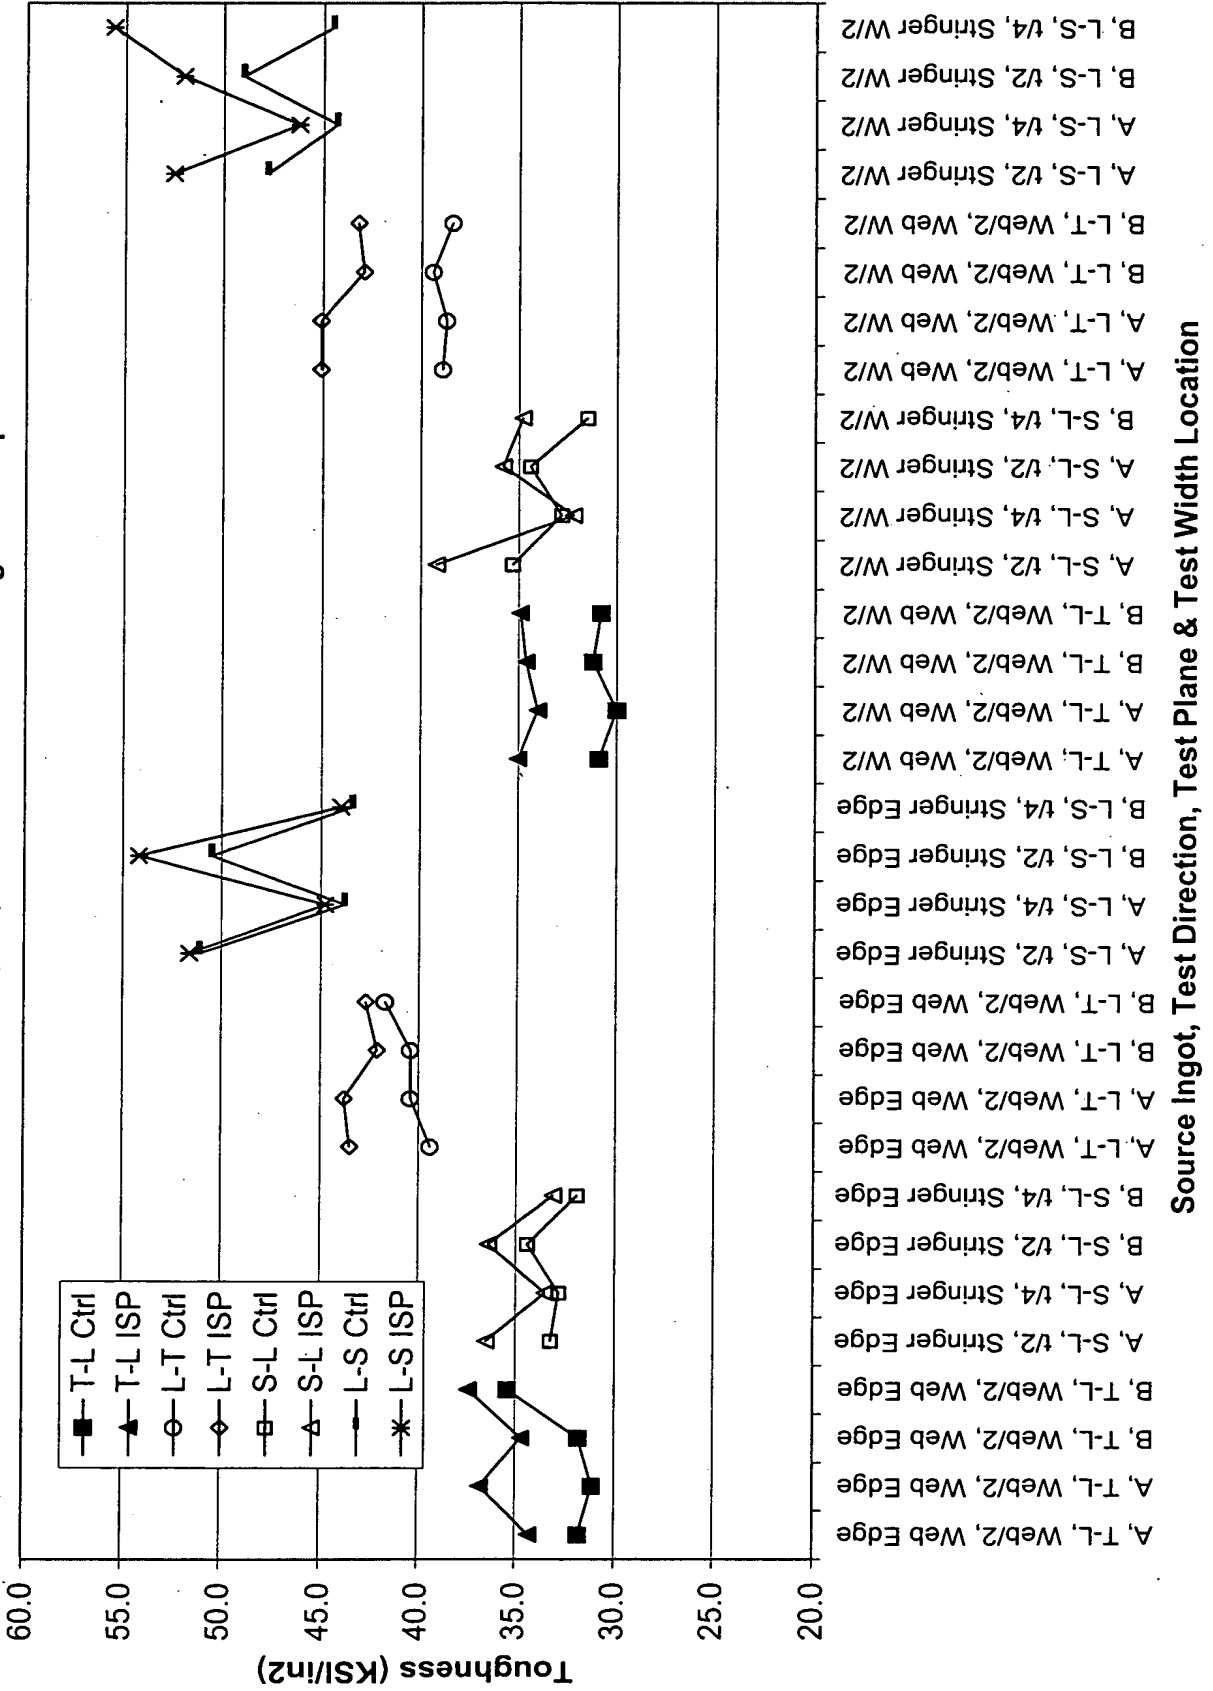
**FIG. 6**  
**T7451 T-L, L-T, S-L & L-S Fracture Toughness K<sub>q</sub> or K<sub>IC</sub>**
